# Manhole Inspection Summary

Manhole # S49I\_\_006MH

Insp Date: **4/1/08 11:06 AM**

**Location** Address: **500 S Luzerne st**

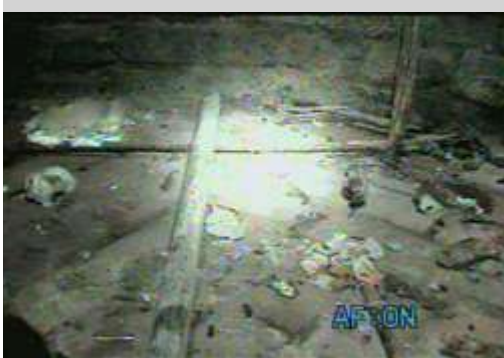
Miscellaneous

bench debris

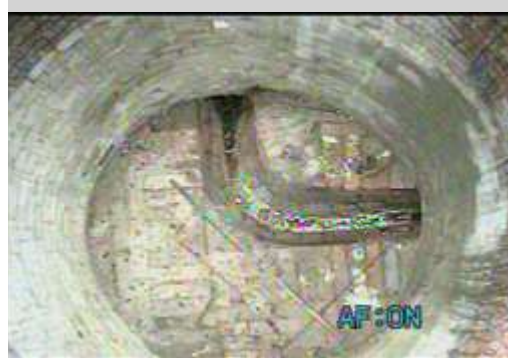
Defect 2

Infiltration: ☐ None ☐ Joint ☐ Cracks ☐ Mortar ☐ Roots ☒ **Wall**

barrel infiltration

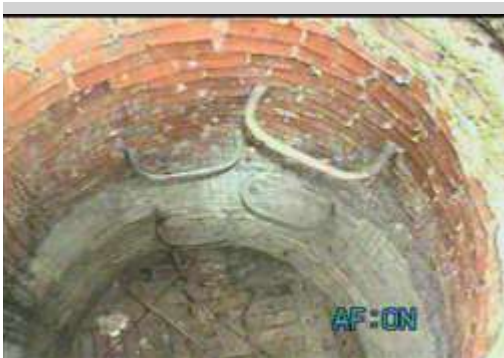
Defect 1

**Steps** Count: **4** Missing: **0** ☒ **Corroded**

corroded stairs

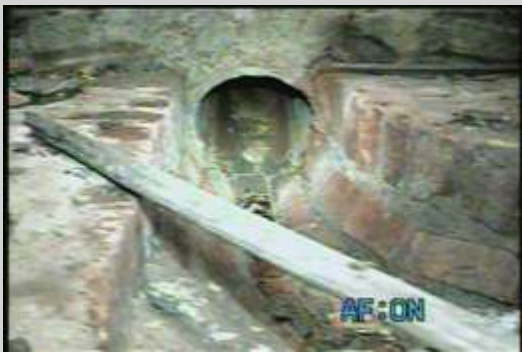
12 O'Clock Outflow

8 in. Circular Gravity Sewer  
Pipe Out @ 12 O'Clock

Invert Depth: **8.08** (ft.) Flow Characteristics: **Slow**

Infiltration: **None** Pipe Seal Cond: **Unknown**

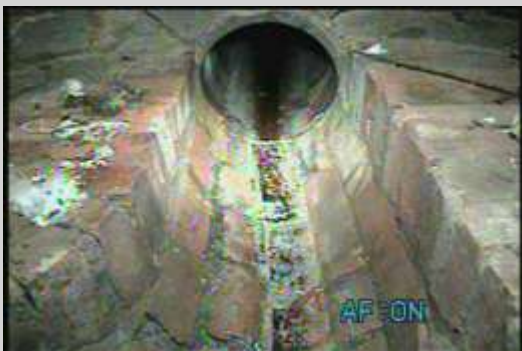
3 O'Clock Inflow

8 in. Circular Gravity Sewer  
Pipe In @ 3 O'Clock

Invert Depth: **7.94** (ft.) Flow Characteristics: **Slow**

Infiltration: **None** Pipe Seal Cond: **Unknown**
